Chronic Pump Failure Causing Unacceptable Downtime - JB

Repeat failures of CP-235 causing unacceptable downtime

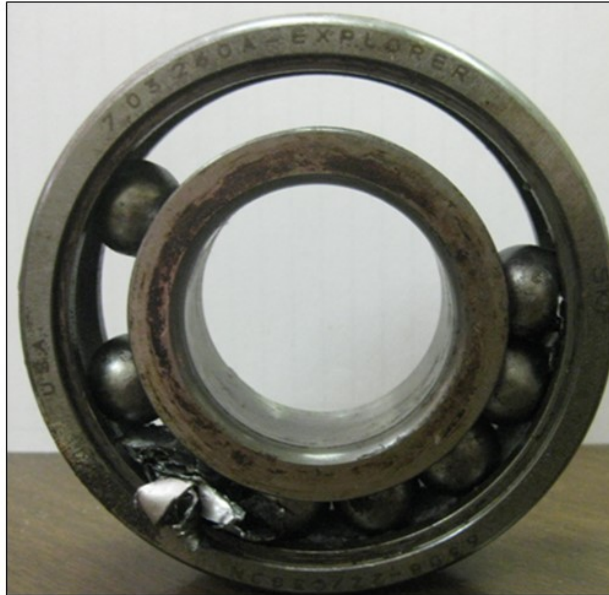
CONTRIBUTING FACTOR	Looseness	–	1 ▼
FINDINGS	Further review of vibration records showed that looseness most likely also played a role in the fatigue of the bearing.

Failed Bearing

PHYSICAL	Misalignment	1. Replace bearing and align properly	1 ▼
FINDINGS	It was discovered that mechanics were using outdated procedure and outdated tools for alignment
