Chronic Pump Failure Causing Unacceptable Downtime - JB

Repeat failures of CP-235 causing unacceptable downtime

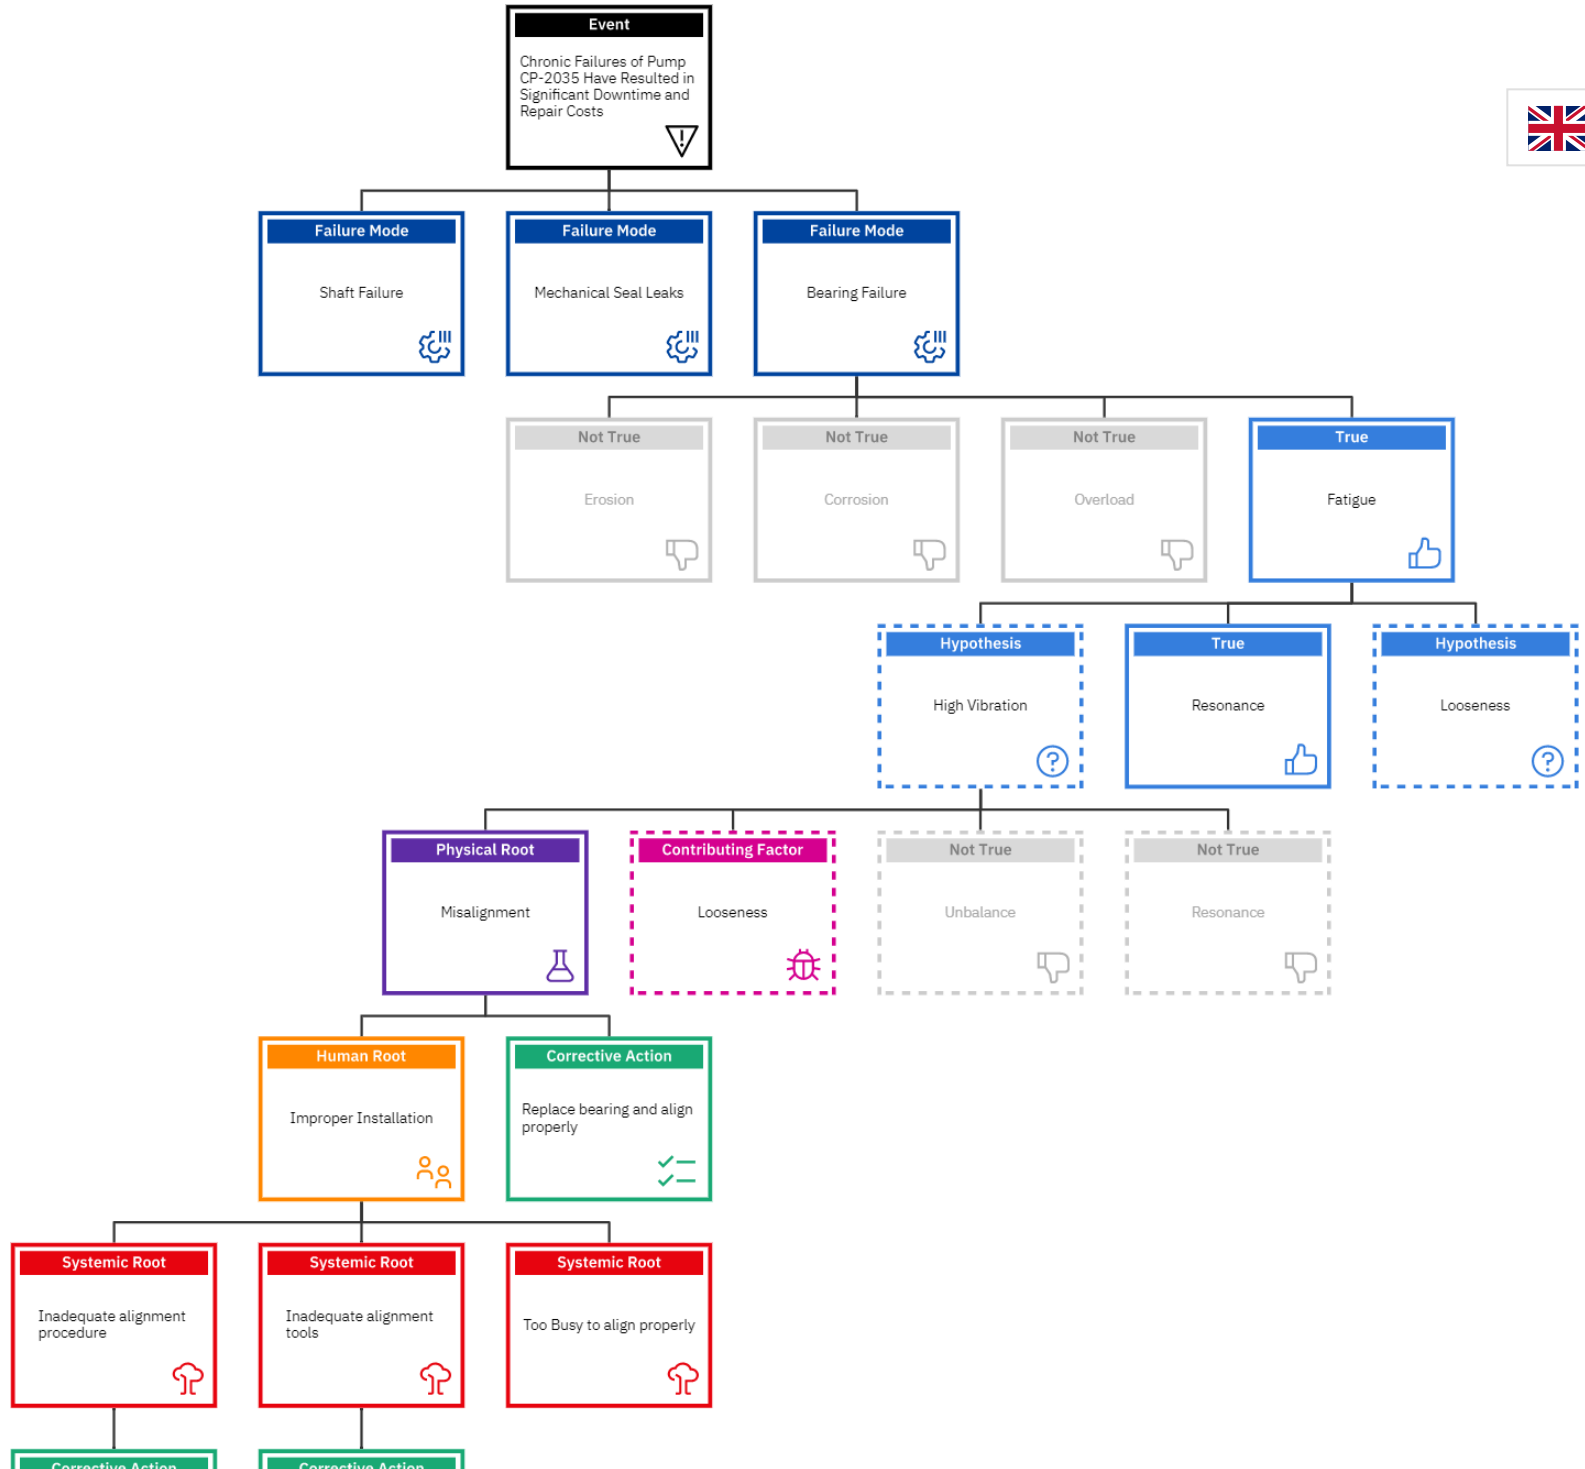
PHYSICAL	Misalignment	1. Replace bearing and align properly	1 ▼
FINDINGS	It was discovered that mechanics were using outdated procedure and outdated tools for alignment

CONTRIBUTING FACTOR	Looseness	–	1 ▼
FINDINGS	Further review of vibration records showed that looseness most likely also played a role in the fatigue of the bearing.

Failed Bearing
